United States Department of the Interior
National Park ServiceNational Register of Historic Places
Registration Form

historic name Johnson, Wilbur T. and Rhoda Stephens, House
other names/site number Missouri State DAR Headquarters
Roslyn Heights, 0-32

street & number 821 Main N/A not for publication
city, town Boonville N/A vicinity
state Missouri code MO county Cooper code 053 zip code 65233

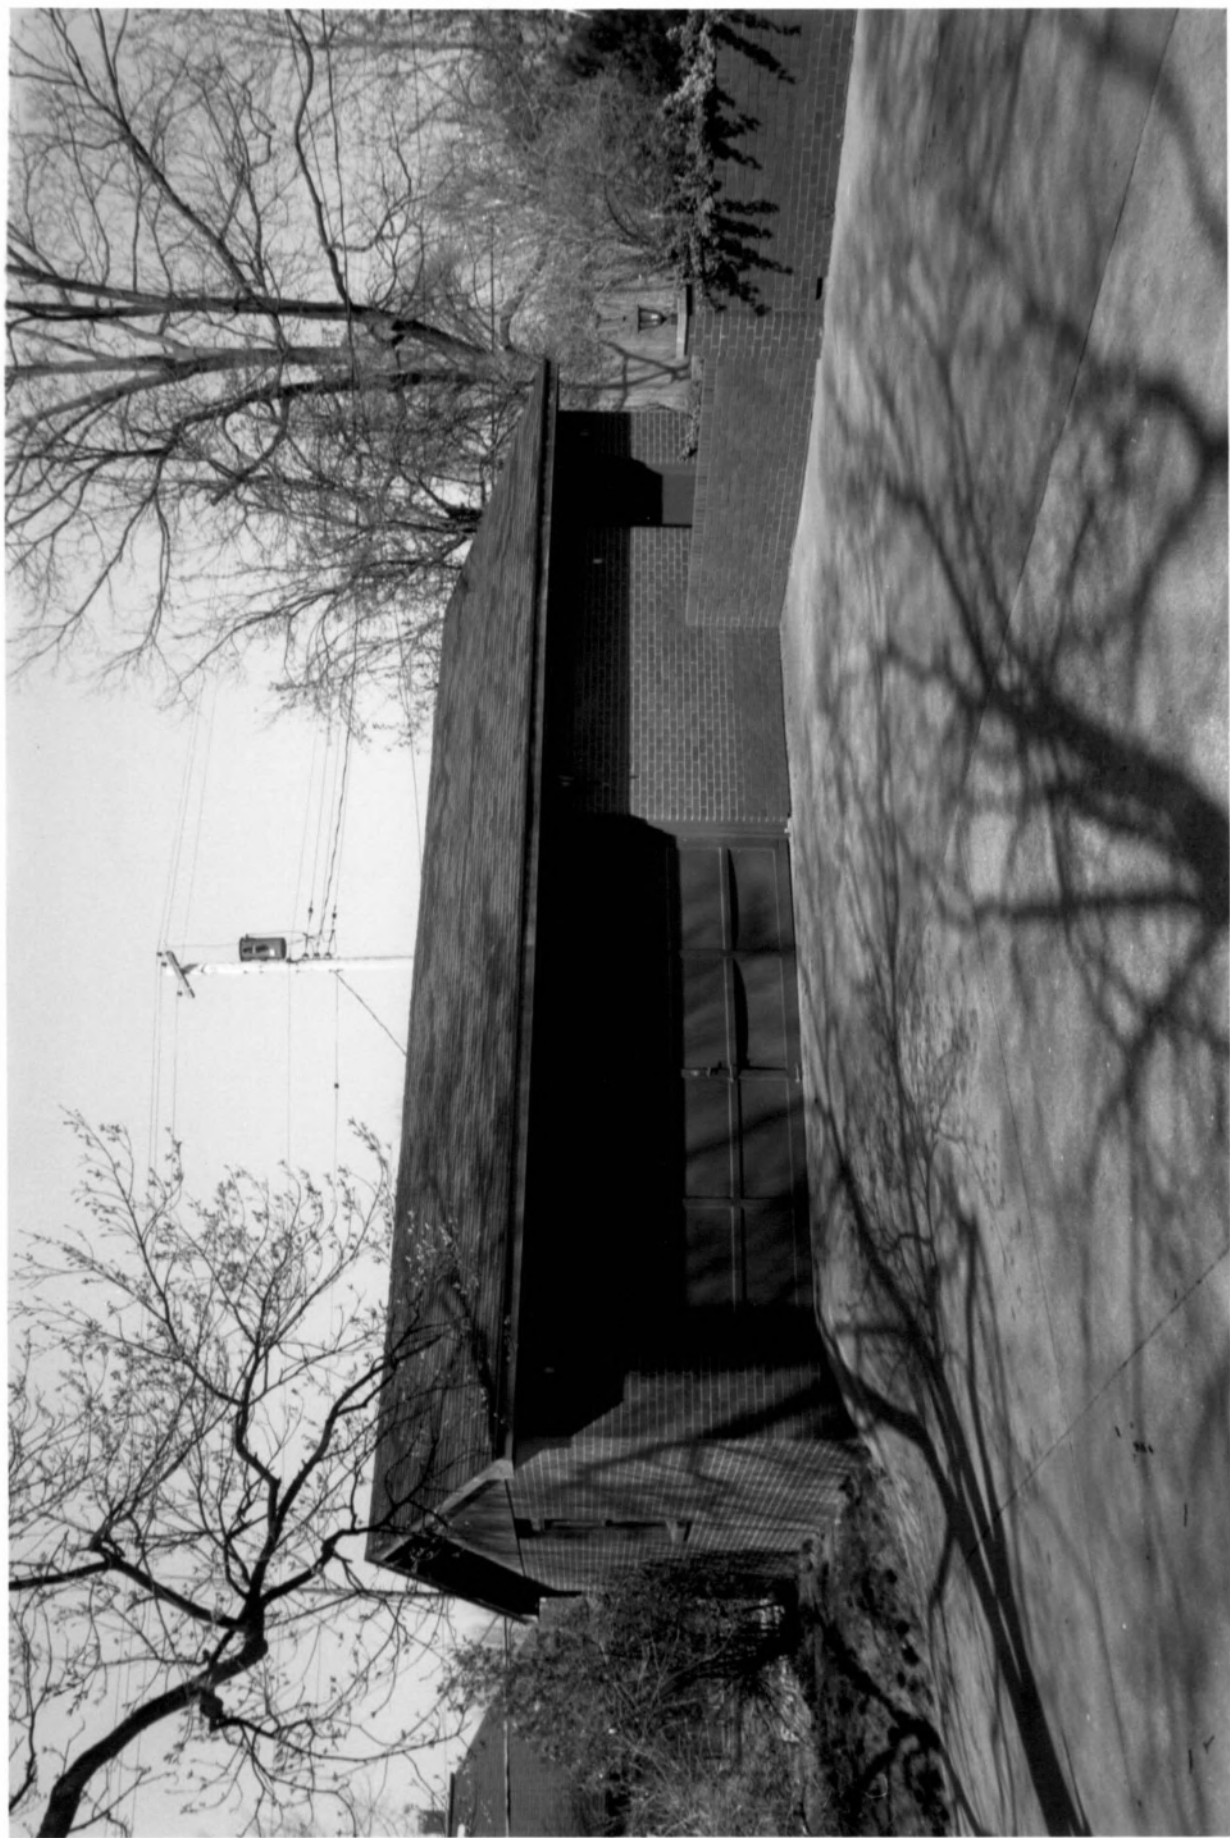
Johnson, Wilbur T. and Rhoda Stephens, House
821 Main Street
Boonville, Cooper County, Missouri
Steve Mitchell
April 12, 1989
Missouri Cultural Resource Inventory
Garage, view from Southeast
#11 of 11

This detached residence sits on a high embankment at the northwest corner of Main and Walnut Streets, facing east onto Main. A stone retaining wall delineates the yard. The porte-cochere and a two-car red brick garage of modern date are reached by a circle drive from Walnut Street, now concreted and following the path of the original drive. A non-contributing garage sits to the rear of the lot and is not visible from the front. The brick of the garage blends well with the mansion and every attempt has been made to have the building conform to the site. The rear lawn was professionally landscaped during 1974-75.

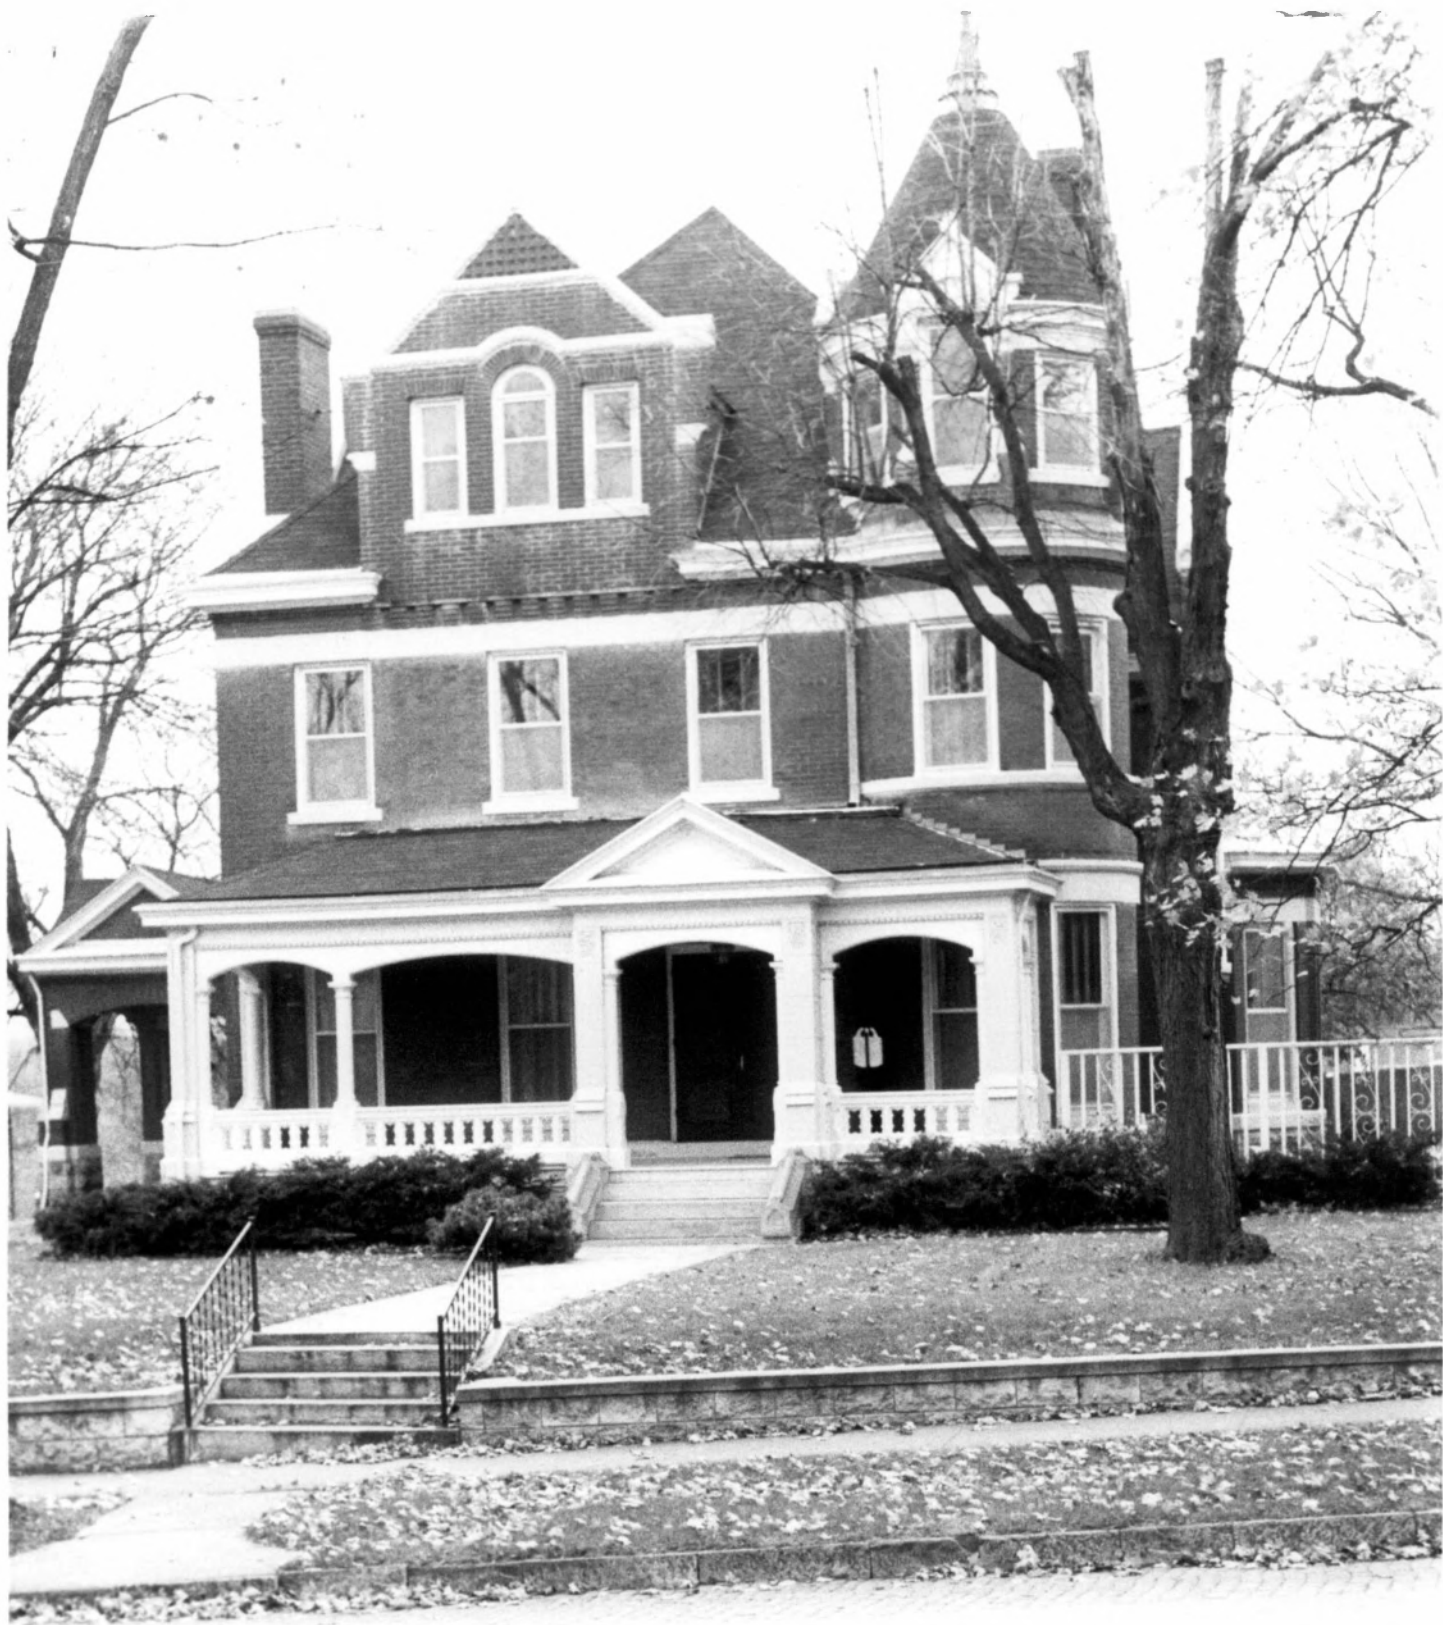
Roslyn Heights
Boonville, Missouri
Maryellen H. McVicker
January 10, 1987
DAR Headquarters at house
Front Facade
Photo #1

Outstanding features include a one-story hip roofed porch with pediment over a double leaf entrance and transom. Paneled front doors open from the front porch into a room-sized reception hall. The original storm doors have etched glass panes with the initials "WTJ" on each for Wilbur T. Johnson, the original owner. These doors open into a small entrance hall, and when left opened, flush with the entrance wall leading into the reception area, create one continuous wall. Moorish decorations embellish the doors in keeping with Moorish ornamentation found in the reception area. The hall has its original

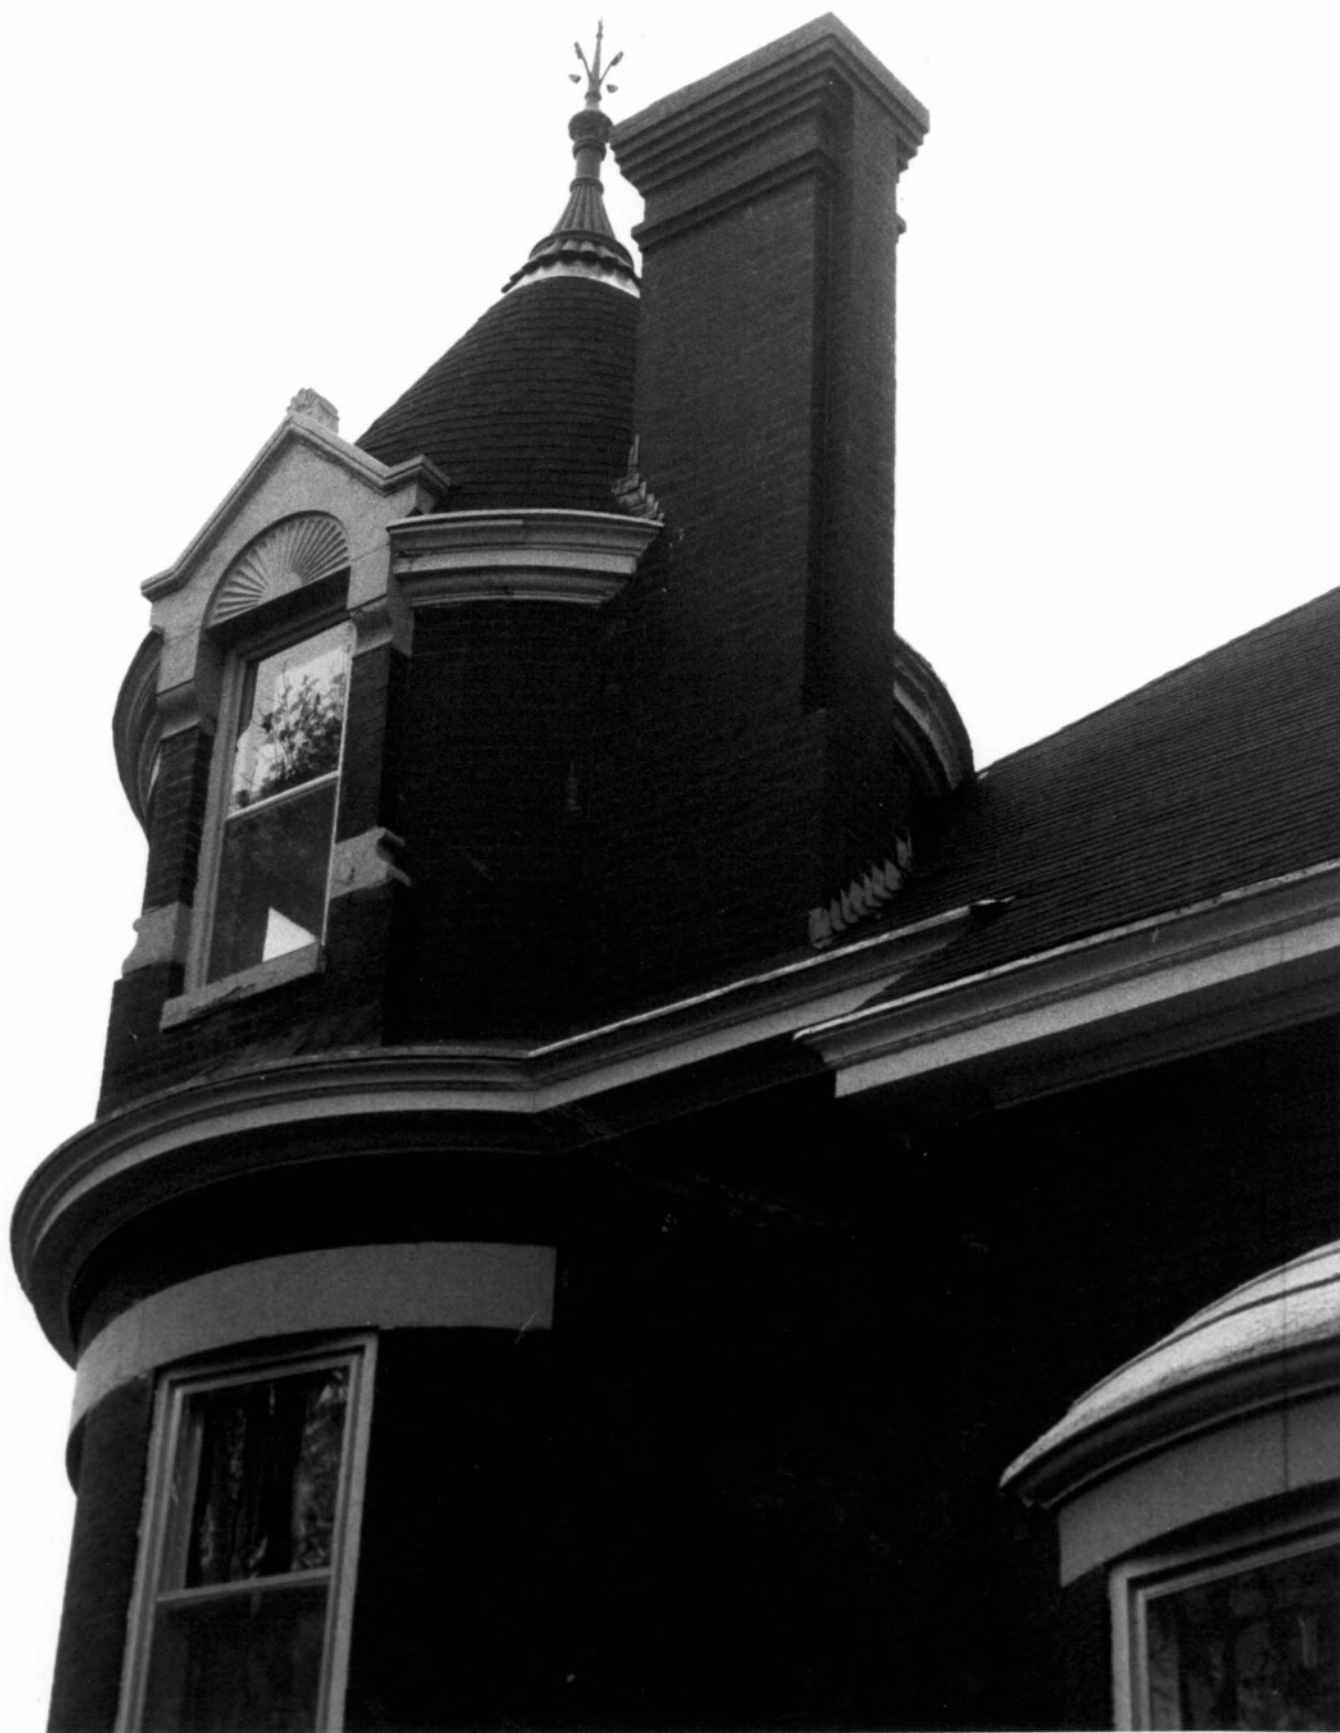
Roslyn Heights
Boonville, Missouri
Maryellen H. McVicker
January 10, 1987
DAR Headquarters at House
Tower on North Facade
Photo # 2

Interesting features on the north elevation include an oriel window with a corbelled brick base and a one-story polygonal brick bay window. The second floor, as on the east elevation, has plain windows with stone lintels and lug sills. This elevation possesses a gabled dormer identical to the facade dormer. A corbelled brick chimney rises next to the tower.

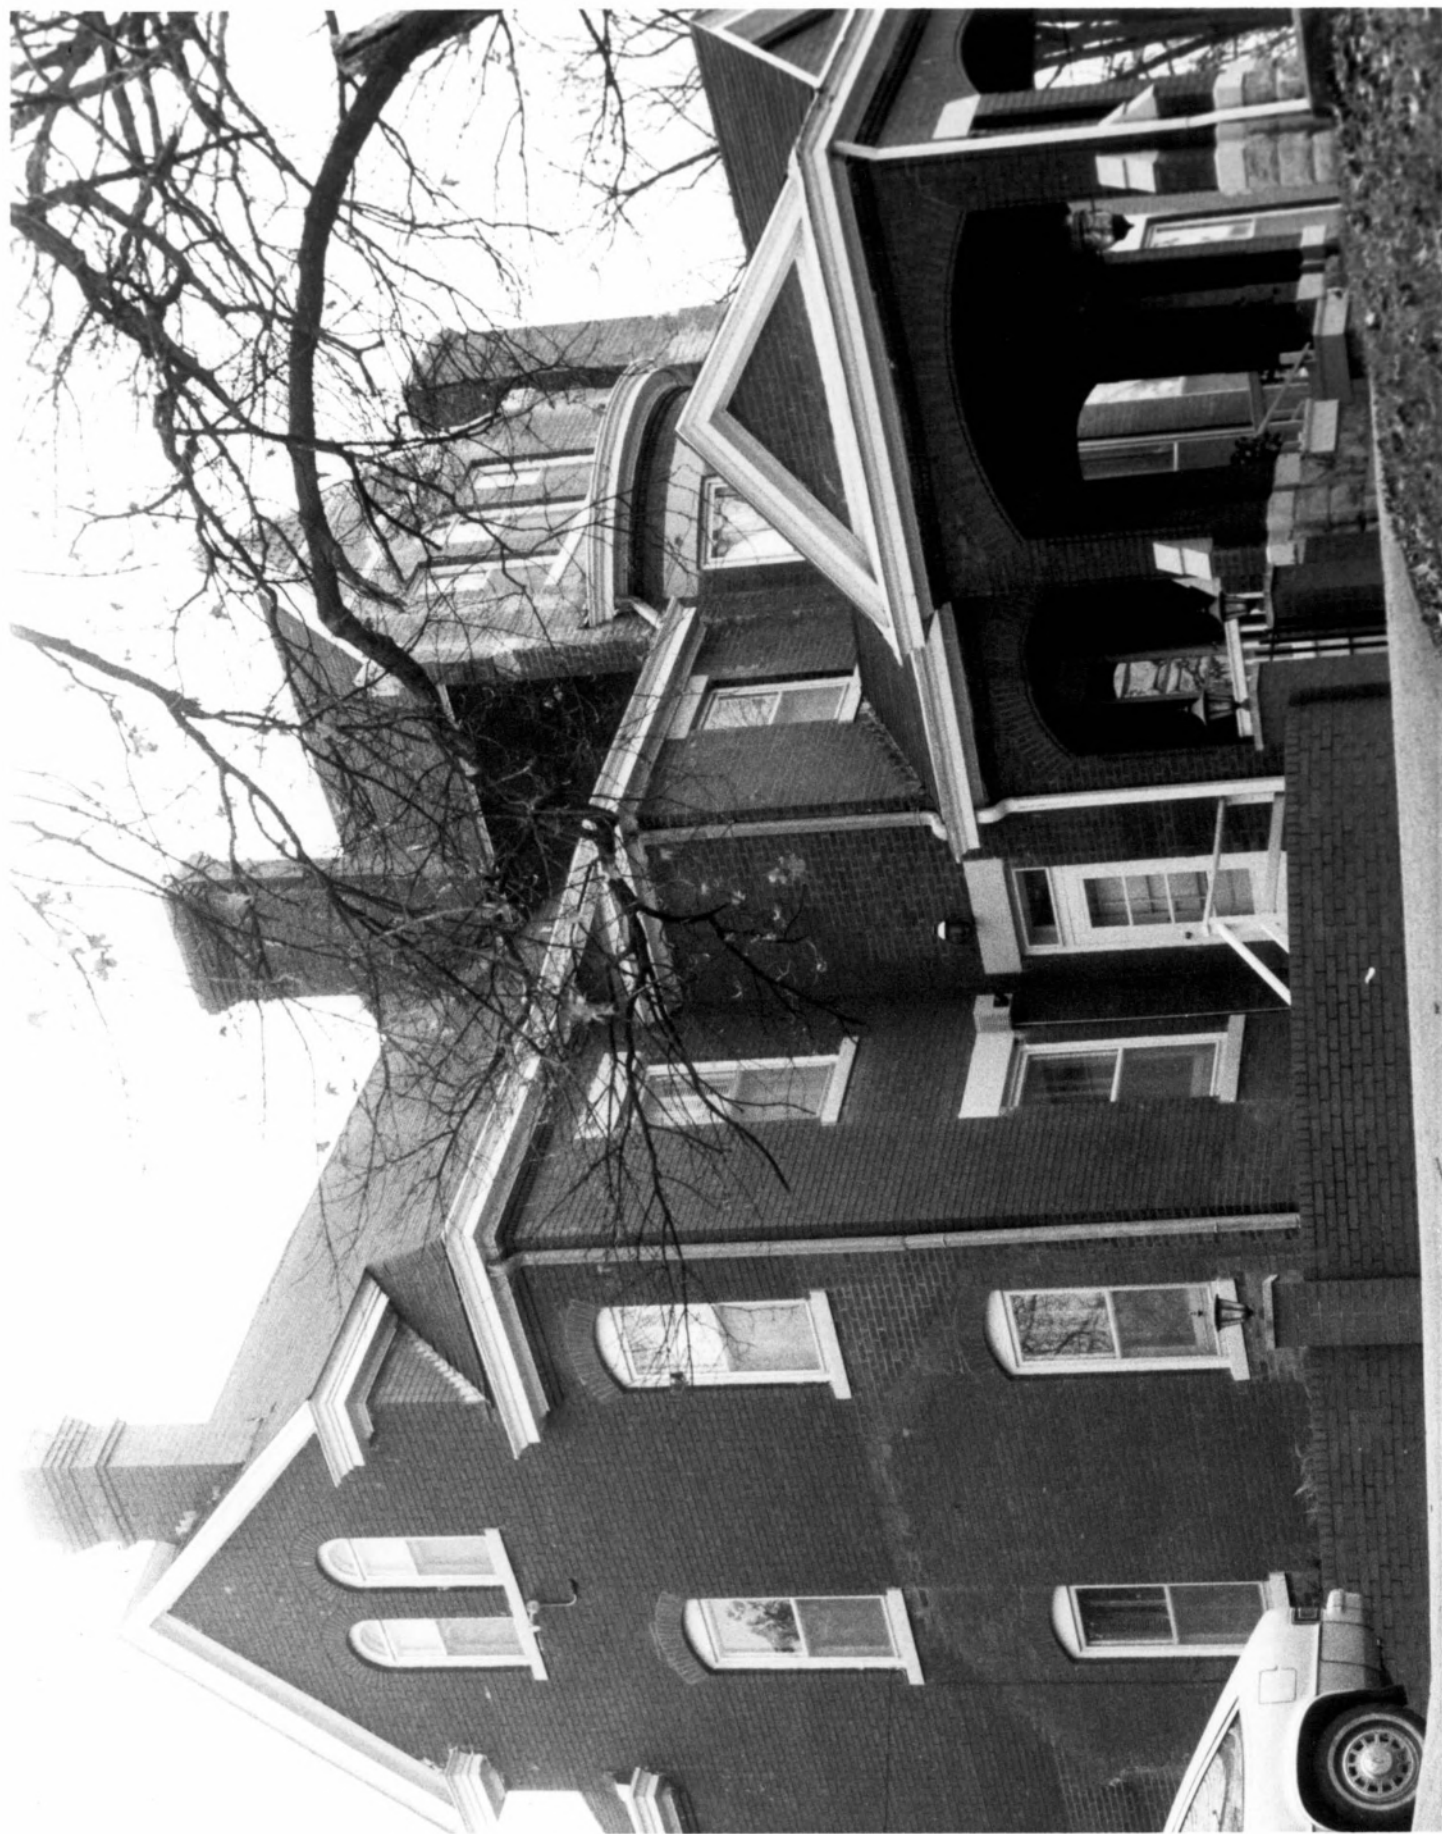
Roslyn Heights
Boonville, Missouri
Maryellen H. McVicker
January 10, 1987
DAR Headquarters at House
West and South Facades
Photo #3

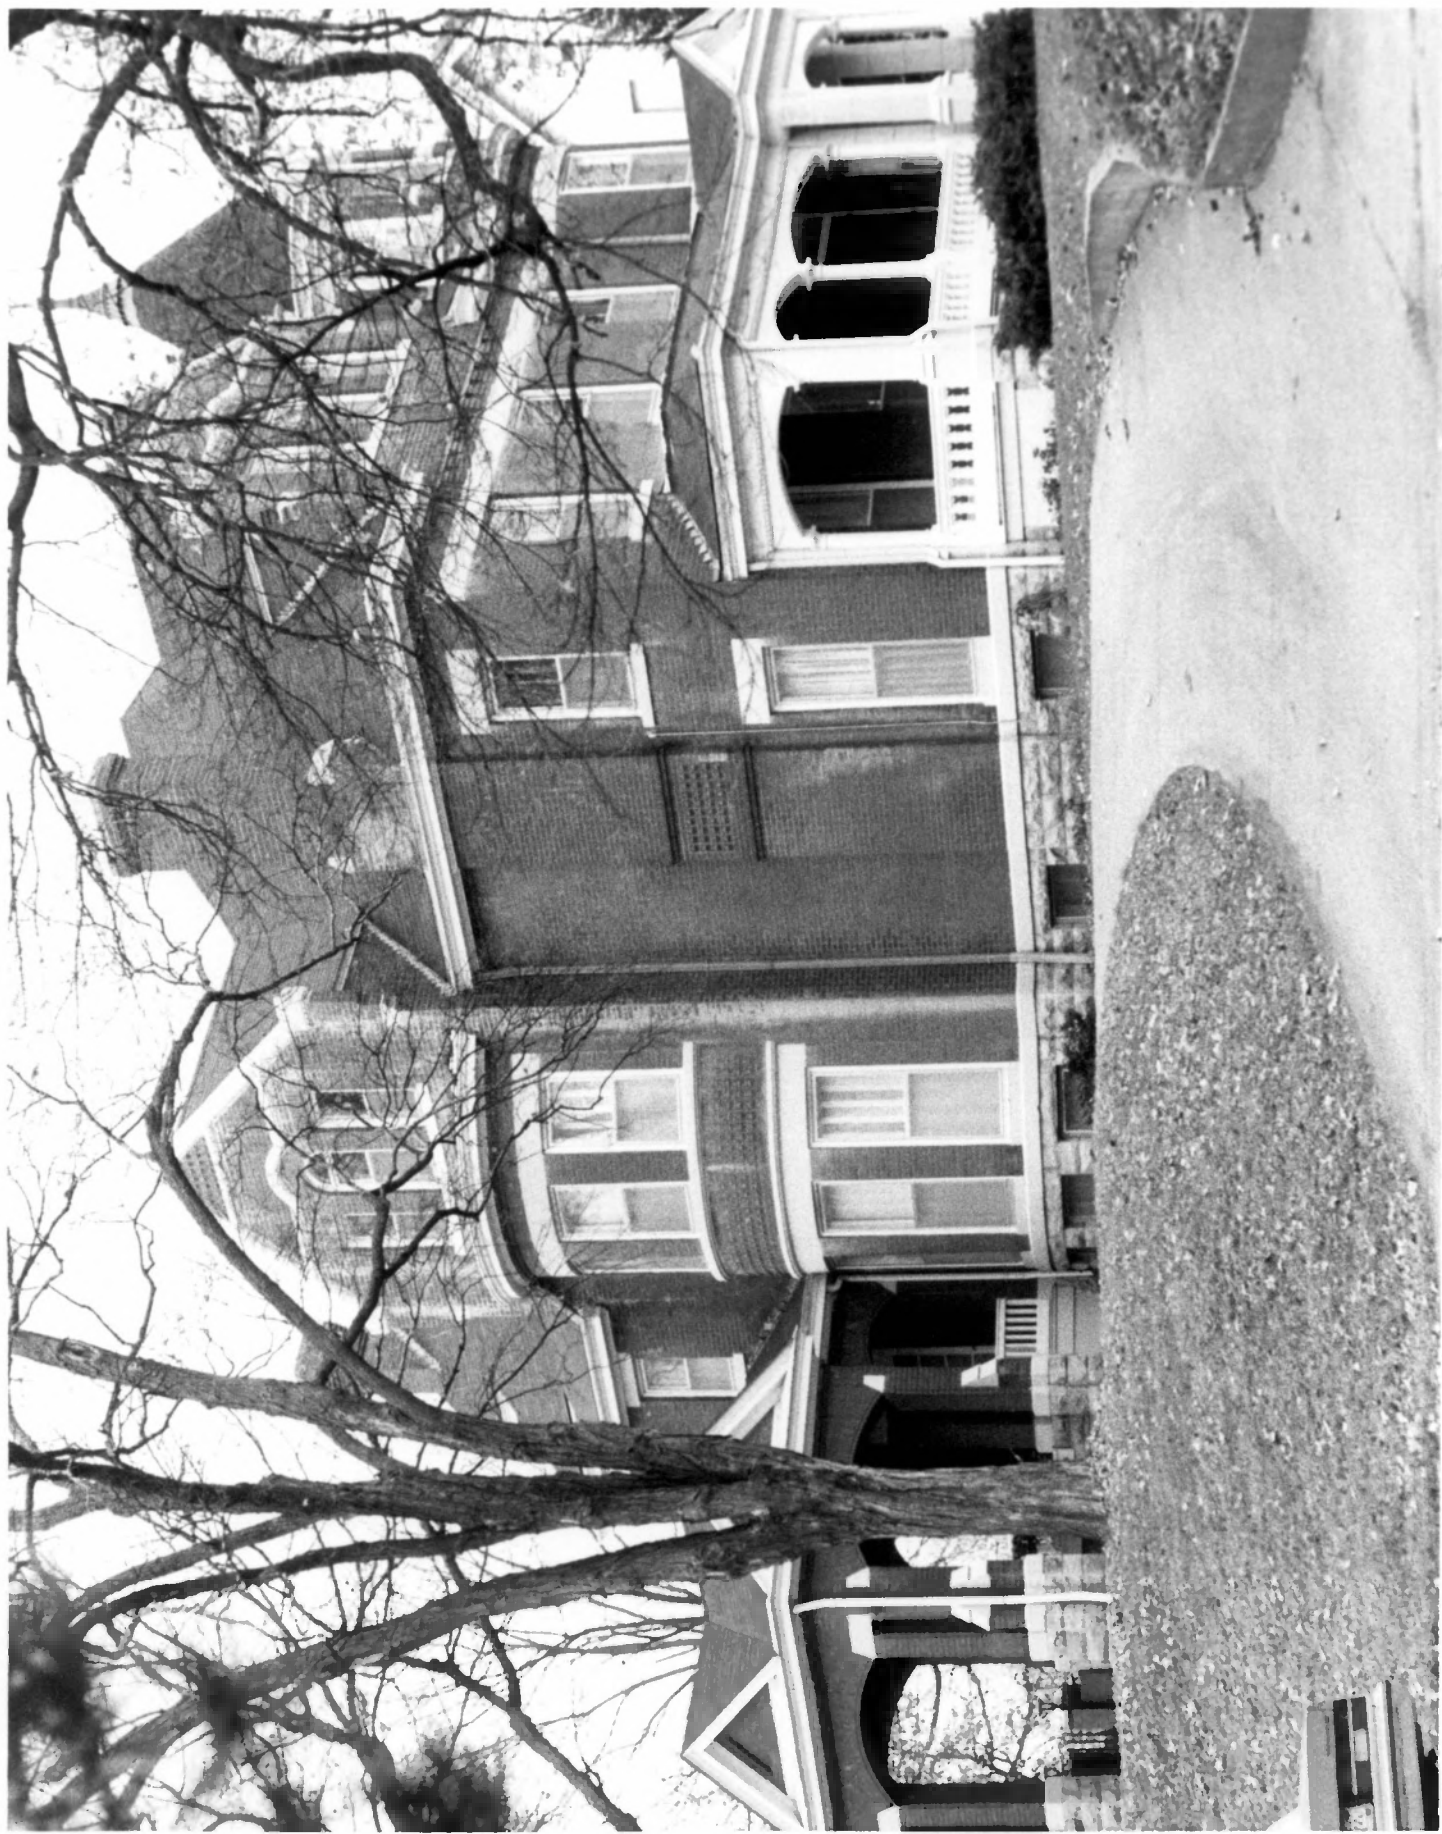
Roslyn Heights
Boonville, Missouri
Maryellen H. McVicker
January 10, 1987
DAR Headquarters at House
South Facade
Photo #4

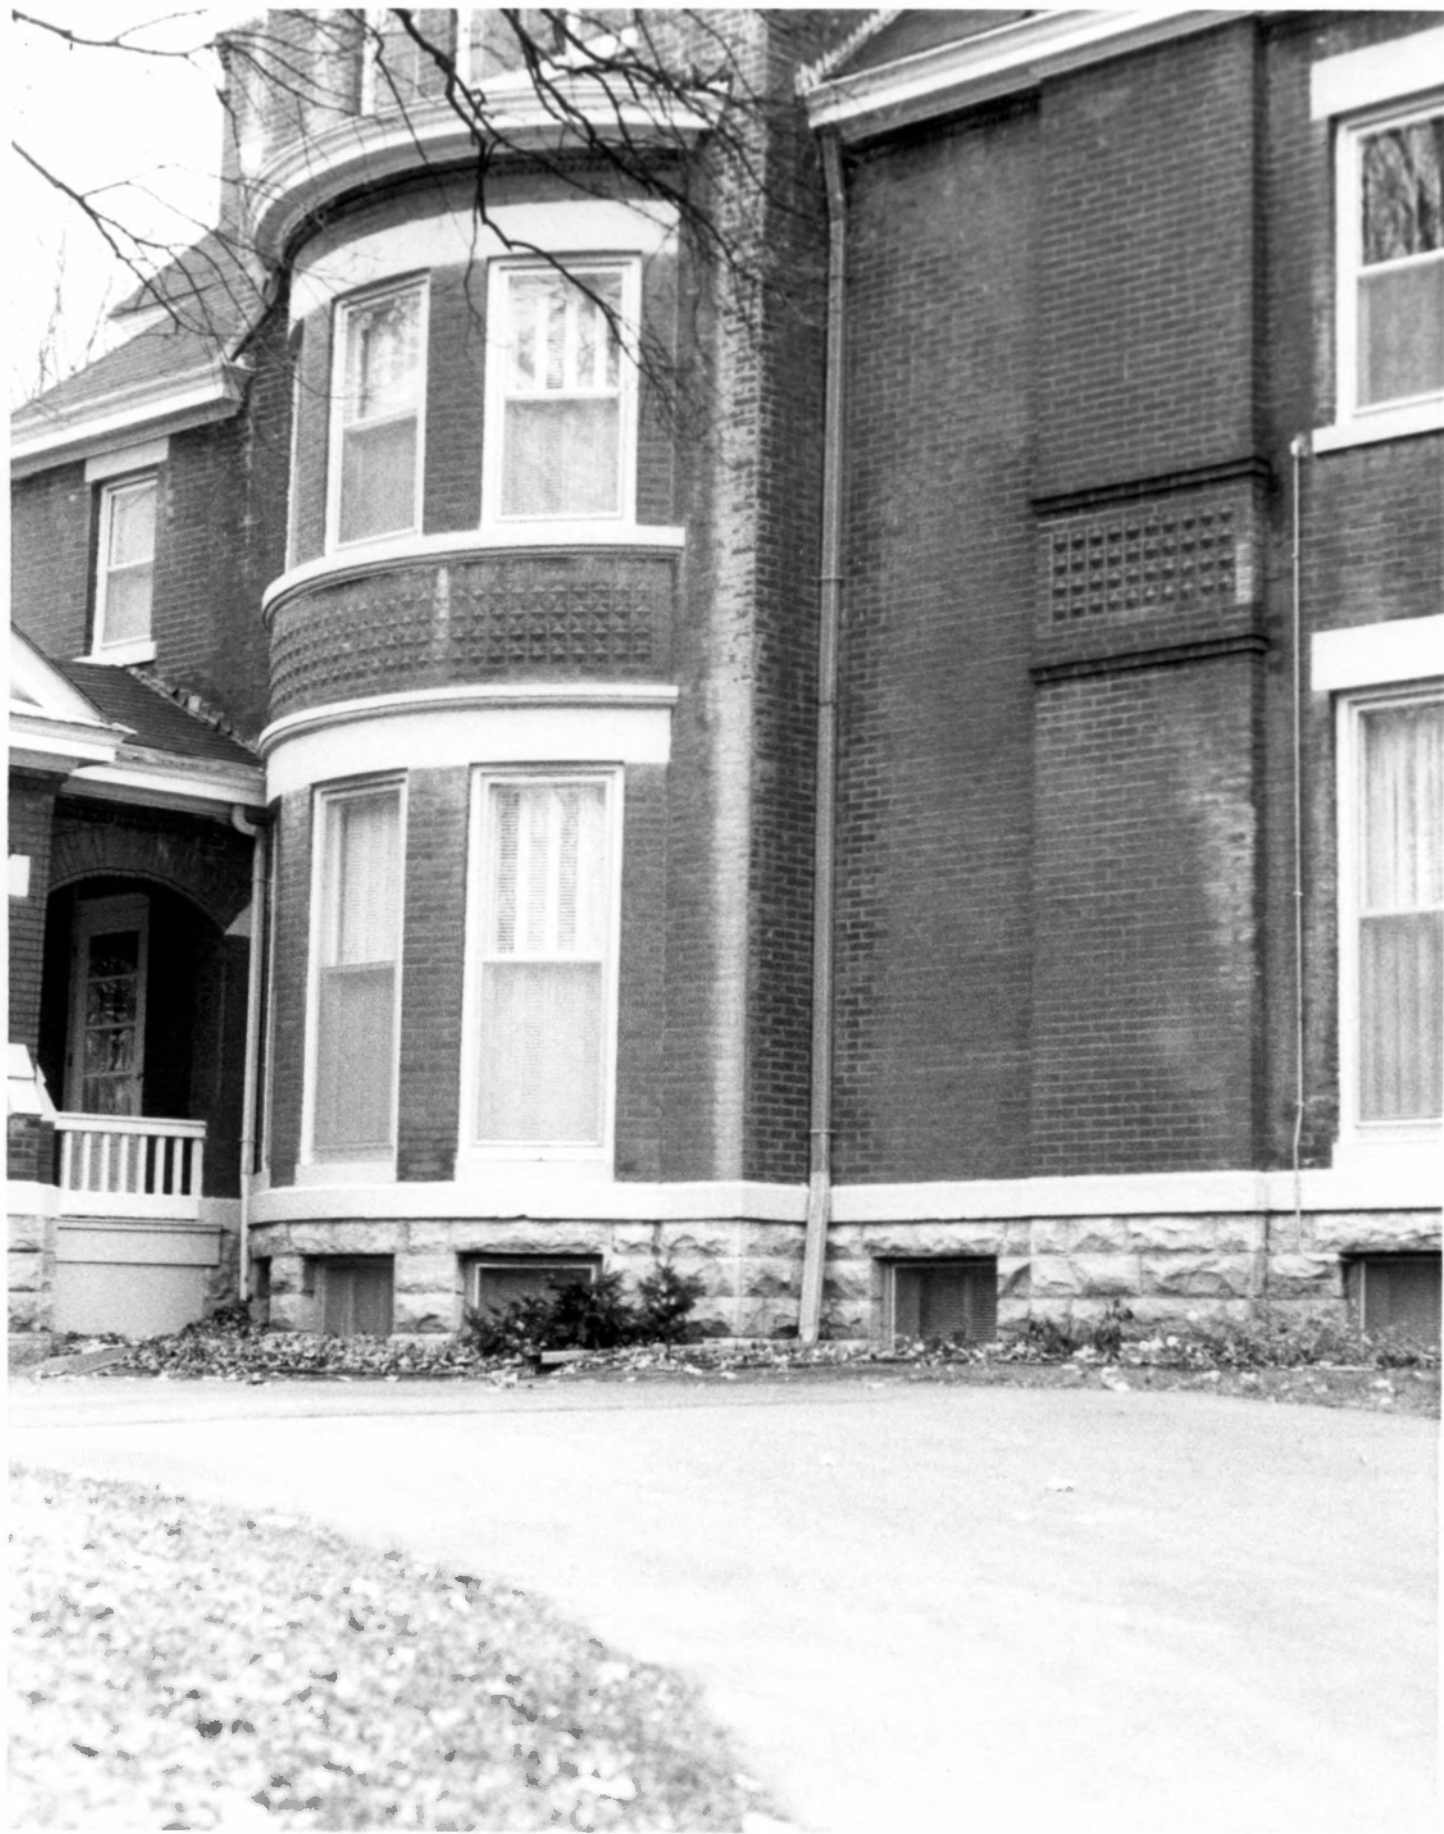
Roslyn Heights
Boonville, Missouri
Maryellen H. McVicker
January 10, 1987
DAR Headquarters at House
Bow Window on South Facade
Photo #5

The south elevation has a large chimney, a two-story bow window, and a secondary entrance which is afforded protection by a hip roofed porte-cochere. The porte-cochere has segmental arches with Moorish decorative elements which appear elsewhere in both the exterior and interior of the house. The gasoliers are original as is the brick sidewalk running along this facade. The two-story bow window contains diamond shaped brick imitating the wood decorative patterning of the Queen Anne style. The windows of the second floor match the rest of the elevations and the front facade. A third gabled dormer tops this facade. The large chimney repeats the design of the others in the decorative brick and corbelled top.

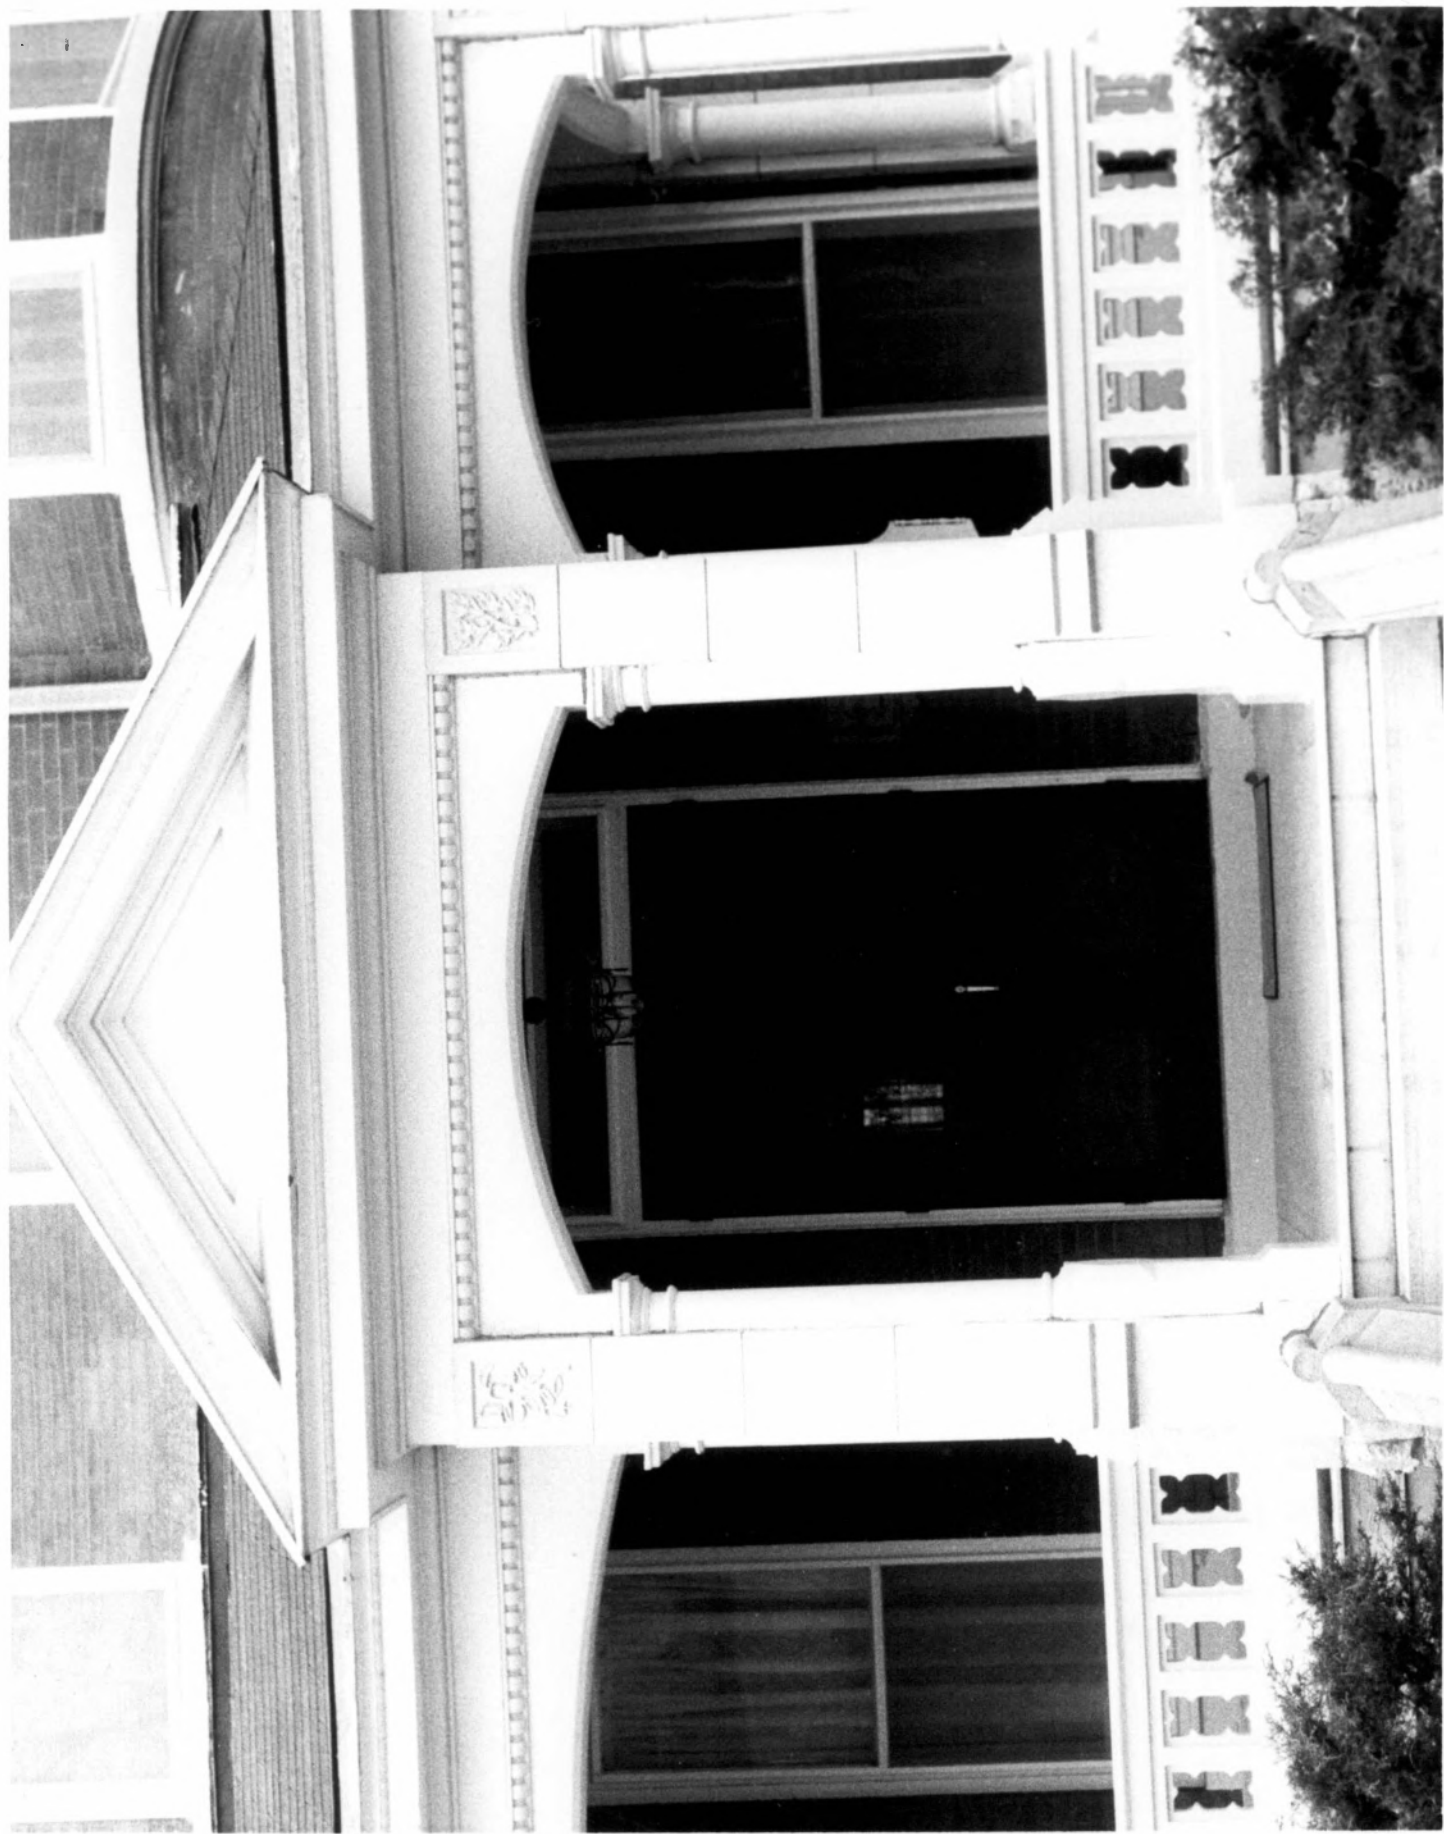
Roslyn Heights
Boonville, Missouri
Maryellen H. McVicker
January 10, 1987
DAR Headquarters at House
Front Entrance
Photo #8

decorative floor tile and an oak grained wall treatment simulates paneled walls. The gasoliers on the porch are original. The modified Doric composition of the porch is accented by Doric pilasters, gutae, and a severely plain entablature and pediment. The three bay second story features plain brick windows and common bond brick; the east elevation's major decorative accents are found on the first and third stories. Three part windows with arcaded headers accent a third floor dormer while windows on the third floor of the facade tower are capped by stone in a sunburst design.

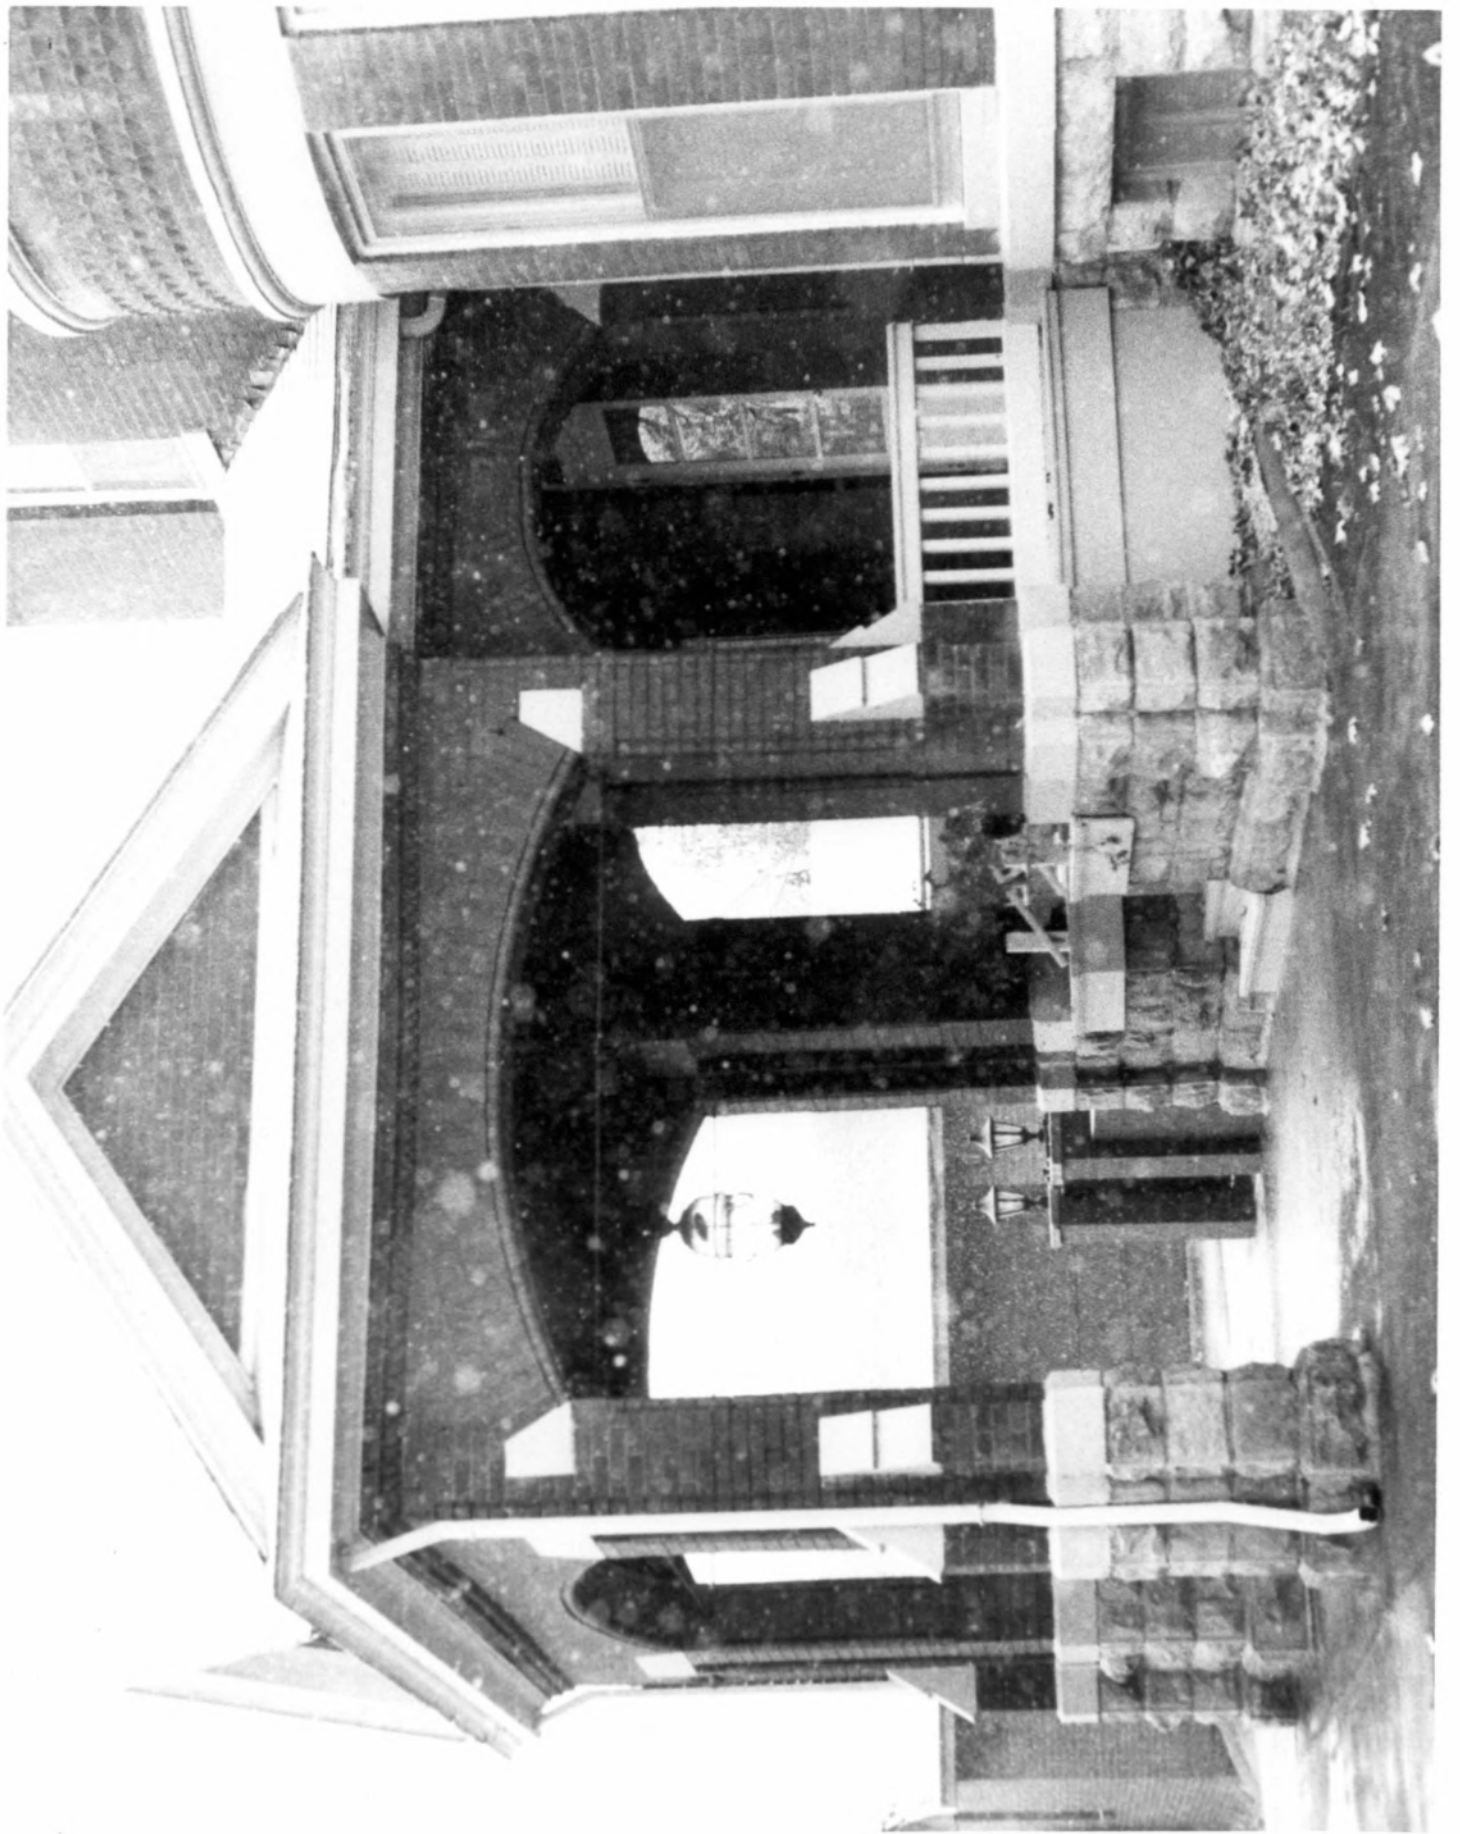
Roslyn Heights
Boonville, Missouri
Maryellen H. McVicker
January 10, 1987
DAR Headquarters at House
Porte Cochere on South Facade
